Rail Accident Report

**Collision between an articulated tanker and a passenger train at Sewage Works Lane user worked crossing, near Sudbury, Suffolk
17 August 2010**

Collision between an articulated tanker and a passenger train at Sewage Works Lane user worked crossing, near Sudbury, Suffolk 17 August 2010

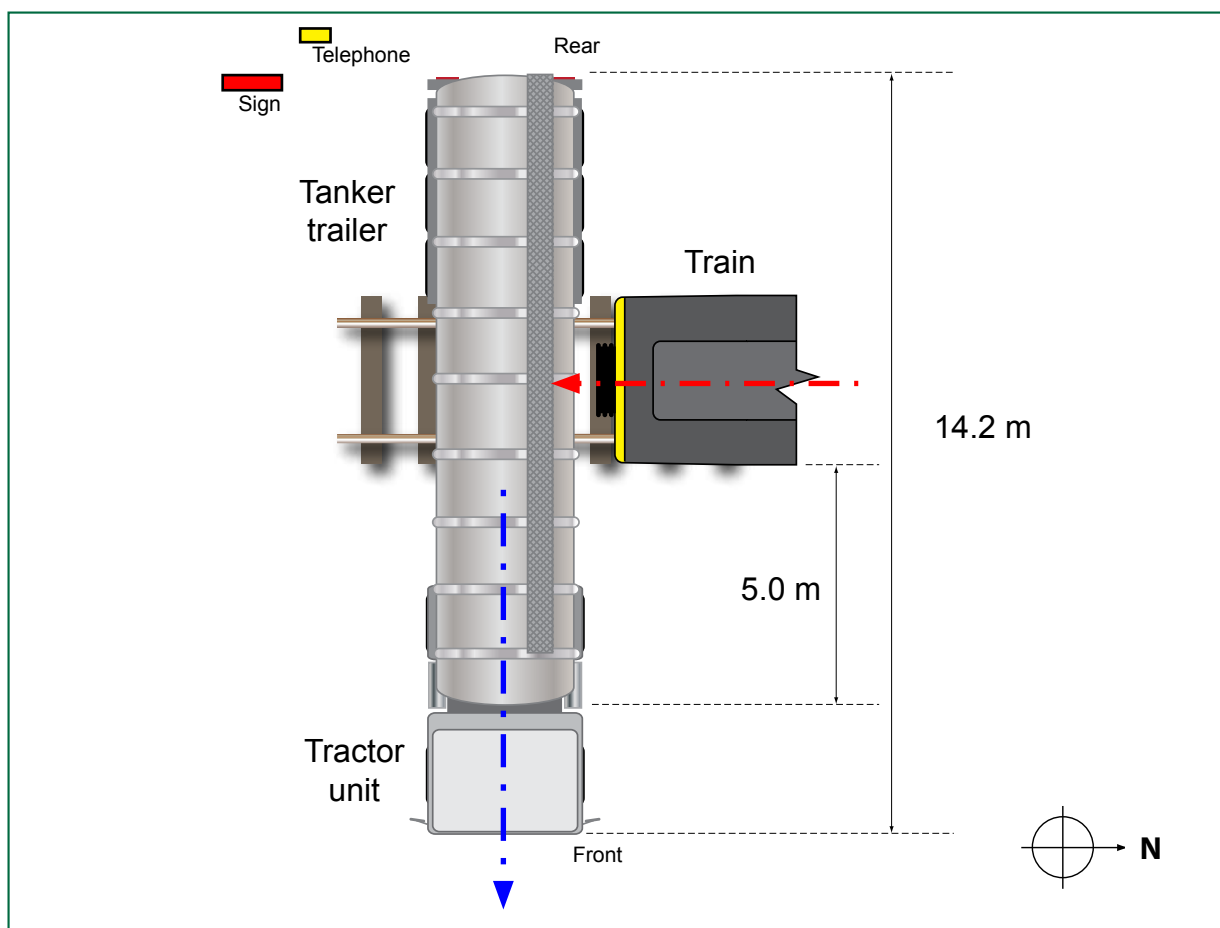
- 36 The point of impact on the tanker was approximately 5 metres from the front of the tank and approximately 8.5 metres from the front of the tractor unit (figure 6). The tractor unit detached from the trailer as a result of the impact and the tank being conveyed on the trailer was breached, causing the contents to cascade over the train. The front of the leading coach of the train was severely damaged by the impact and the coach derailed, but remained upright at an angle, stopping approximately 35 metres beyond the crossing. The rear coach remained on the rails but suffered minor external damage. Both coaches had internal damage to doors, tables and fixings with some of the damage arising from passenger impact. The derailed coach damaged a short parapet alongside the track, with diesel fuel and effluent spilling into a pedestrian/cattle underpass (paragraph 16) below and onto the track.

Figure 6: Diagram of point of impact.

- 82 The damage inflicted on the tanker by the train provides a clear indication of where the tanker was on the crossing when it was struck. The left side of the damage (as viewed from the train) was approximately 5 metres from the front of the tank and approximately 8.5 metres from the front of the tractor unit.

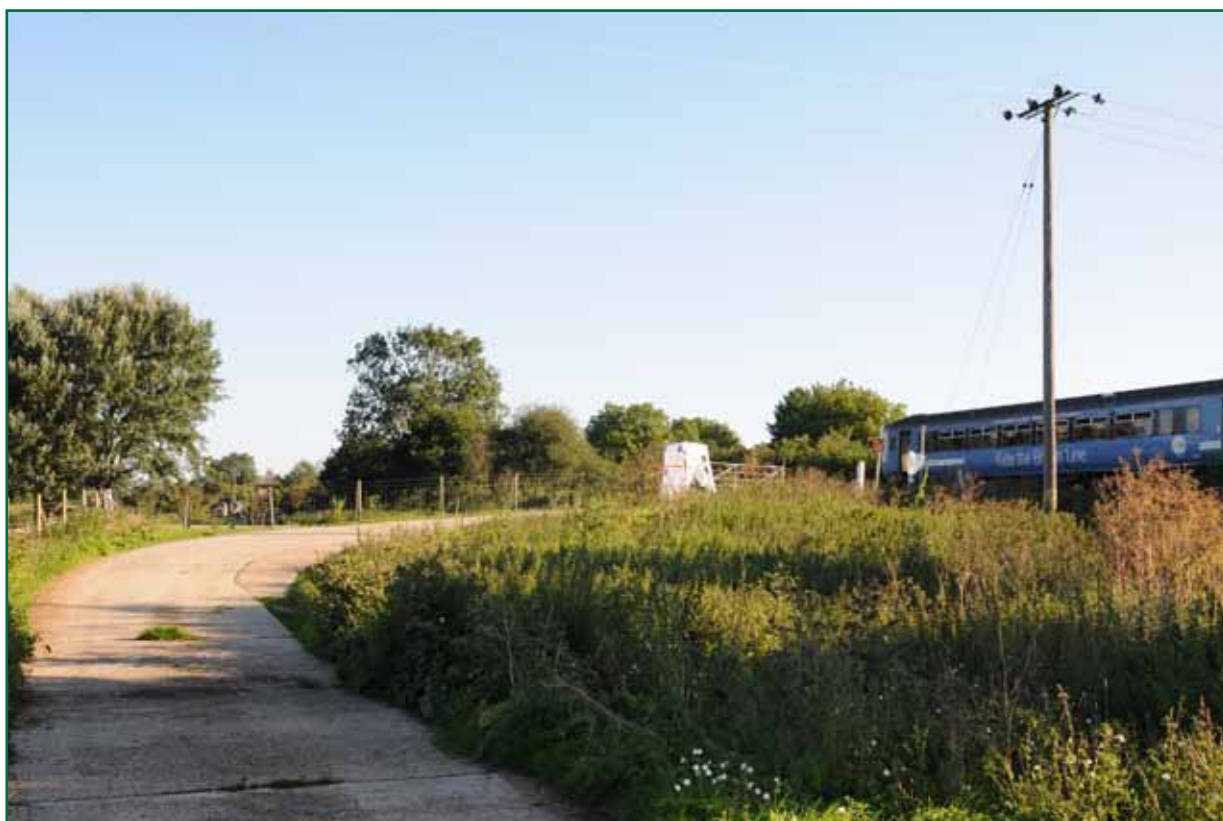
Figure 7: View of the crossing from the exit of the sewage treatment works.

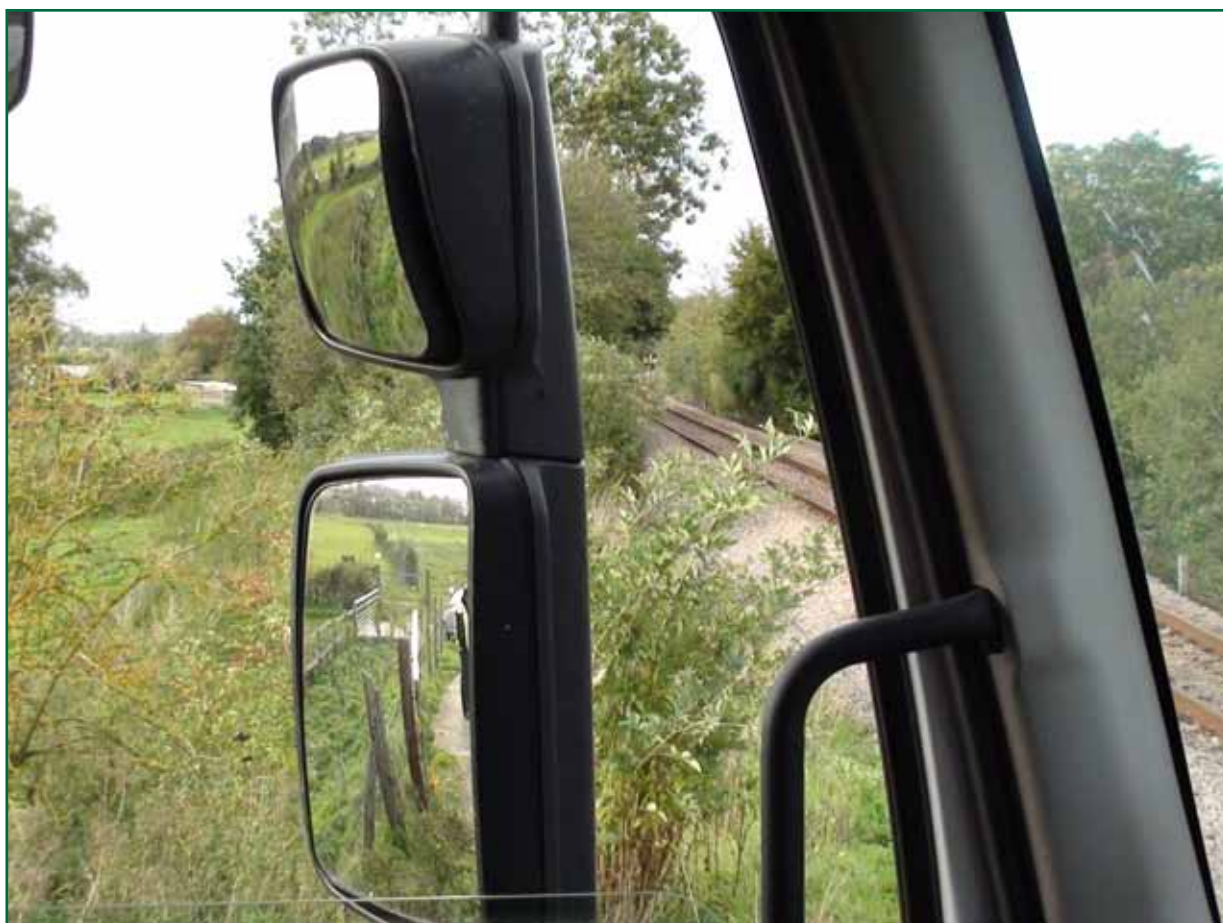
- 88 Table 2 shows that it is possible to see a train approaching from the Sudbury direction when a road vehicle is three metres from the crossing and it may be possible to see it when a road vehicle is four metres from the crossing. Irrespective of the speed at which the vehicle was travelling (up to 4 mph (6.4 km/h), see paragraph 85), the tanker driver would have had an opportunity to look for and therefore see an approaching train and stop the vehicle before it encroached onto the crossing.

Figure 8: View of train taken from the tanker vehicle driving position showing the train beyond Shalfords UWC at around 500 metres (Photograph from the sighting tests on 3 October 2010)

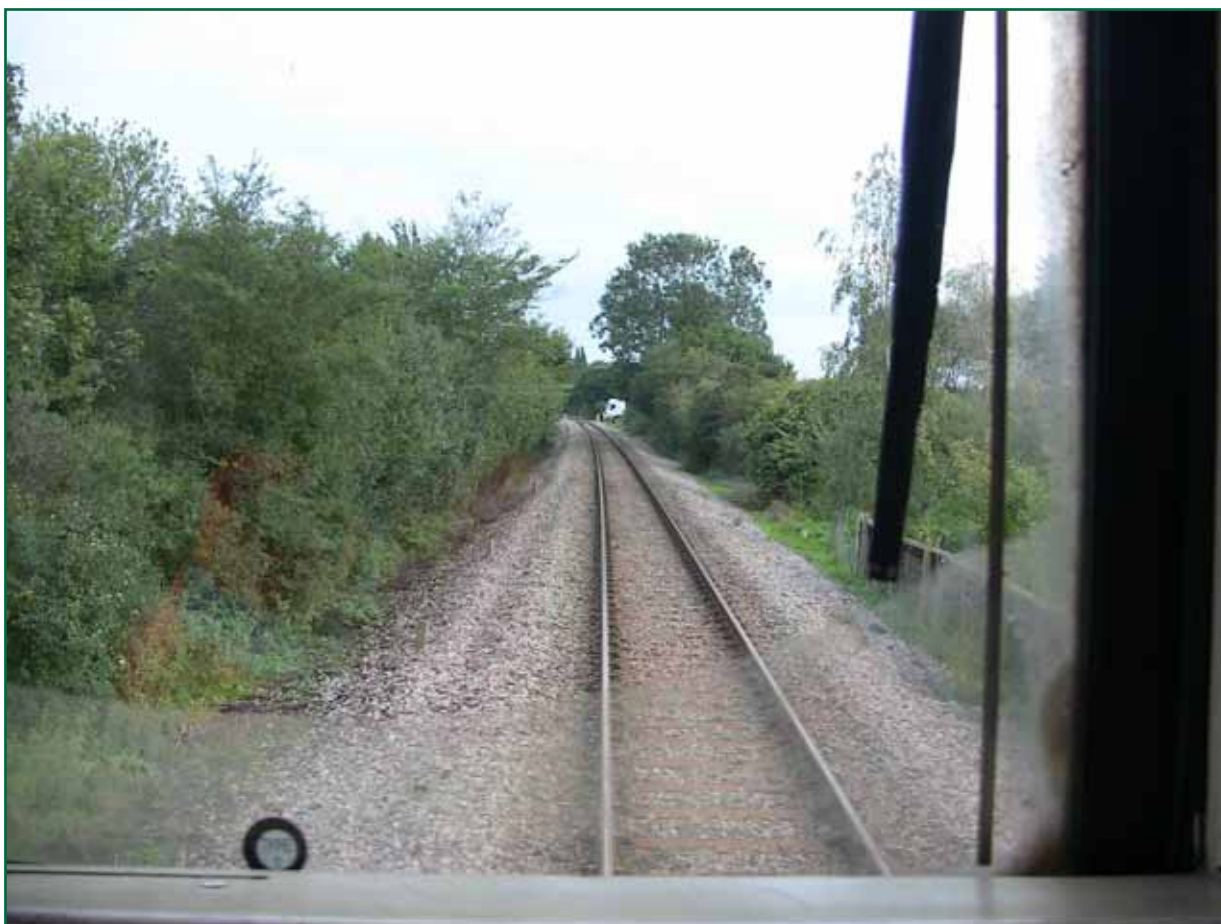
Figure 9: View of tanker from the train driving position at 200 metres (Photograph from the sighting tests on 3 October 2010)

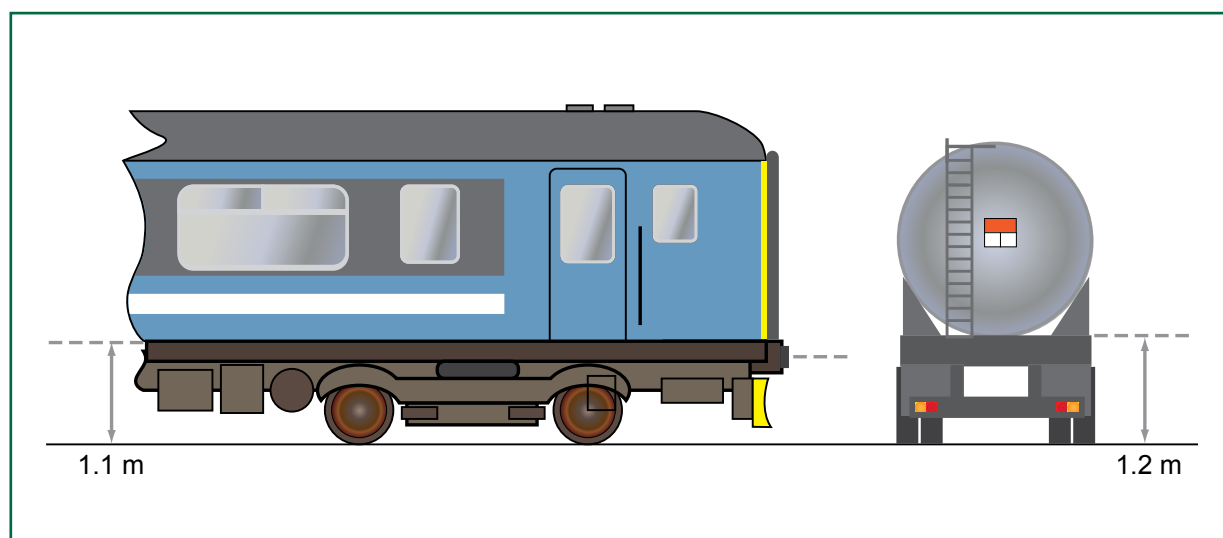
169 In the accident at Sewage Works Lane UWC, the bottom of the tanker barrel was 1.2 metres above the road and at approximately the same height as the floor on the Class 156 unit. As a result, the tanker came halfway up the height of the train body as shown in figure 12 (this type of collision is known as an 'over-riding collision' as the point of impact is above the level at which the energy absorbing devices are normally located on a railway vehicle).

Figure 12: Diagram showing the relative height of Class 156 and sewage tanker

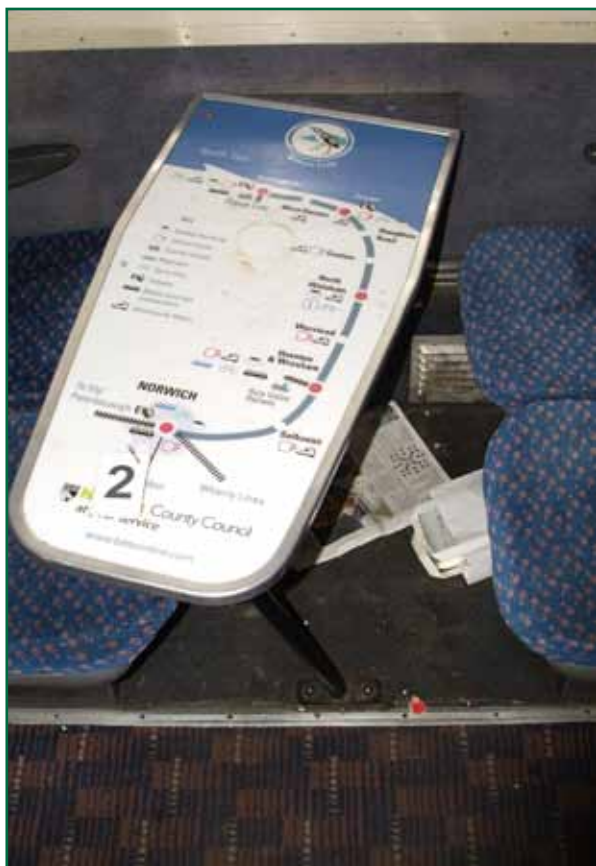
- 172 None of the six rearward facing seats which were occupied showed permanent deformation as a consequence of the accident. The moderate level of deceleration (see appendix E) seen by the interior combined with the single occupancy of all double seats means that the lack of damage to the seats in this accident is unsurprising.
- 173 Three tables on the leading vehicle and six tables on the trailing vehicle were found to be damaged. A typical example of deformation is shown in figure 13.

Figure 13: Typical example of table deformation

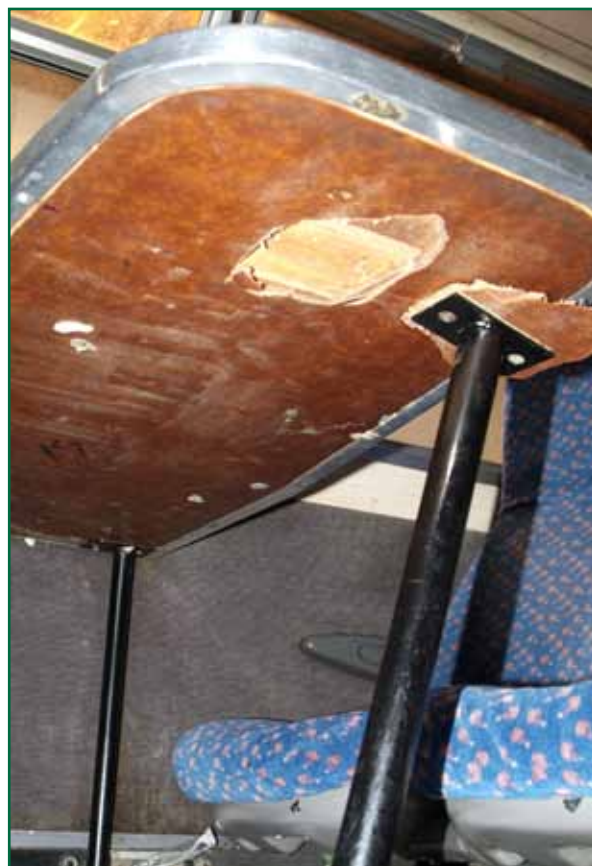
Figure 14: Typical example of table deflection

- 174 The tables deflected in the direction of travel, rotating around one of the corners of the table in contact with the body side. In two cases, the rotation of the tables was only arrested as the front table leg contacted the seat opposite (an example is shown at figure 14). The table top in these cases would have severely intruded into the survival space of the passenger on the seat opposite. Fortunately none of these seats was occupied.
- 175 In several cases, the front leg became fully or partly detached from the table top as shown in figure 14. The tapping plate into which the top of the leg was bolted was pulled through the plywood revealing sharp edges. This is undesirable and would not meet the requirements of current interior standards which require the table to fail in a manner which is not likely to cause injury through secondary impacts.

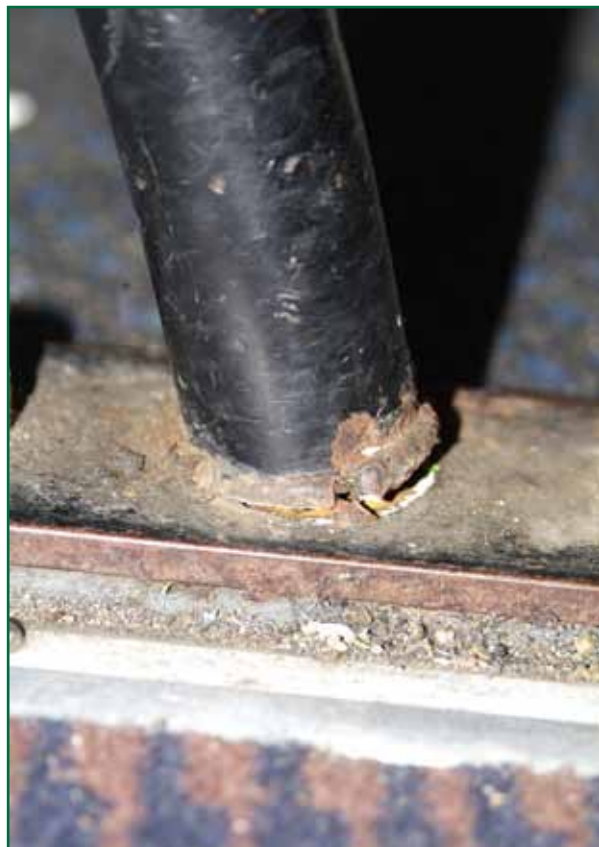
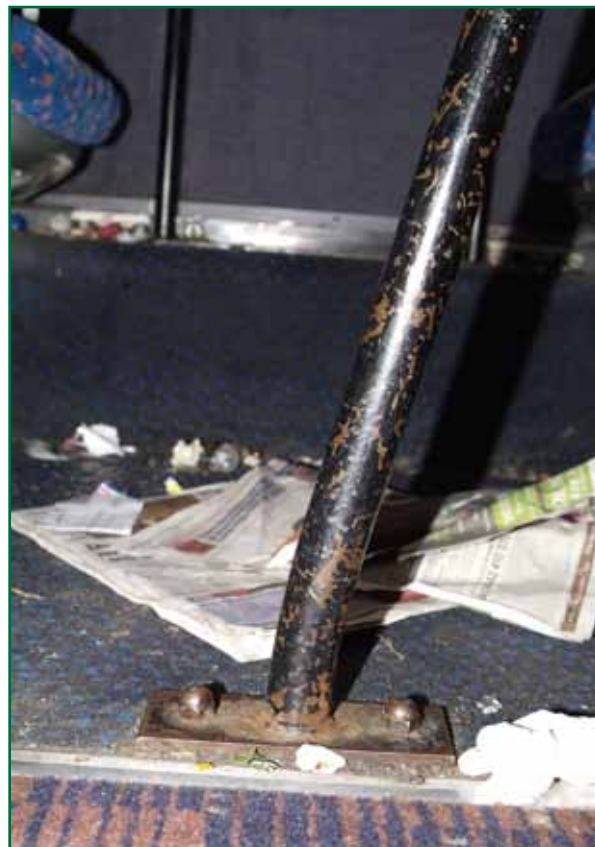
- 176 The front leg connection to the floor exhibited two types of deformation as shown in figures 15 and 16. In seven cases, the table leg bent and deformed plastically without material failure. In two cases, the table leg failed at the weld to the base plate. This meant that the table leg provided little or no energy absorption due to the inadequate weld strength.

Figures 15 and 16: Damaged legs at base of interior tables within the vehicles

- 177 Overall, the performance of the tables resulted in the potential for survival space to be compromised and the severity of the injuries to be increased.

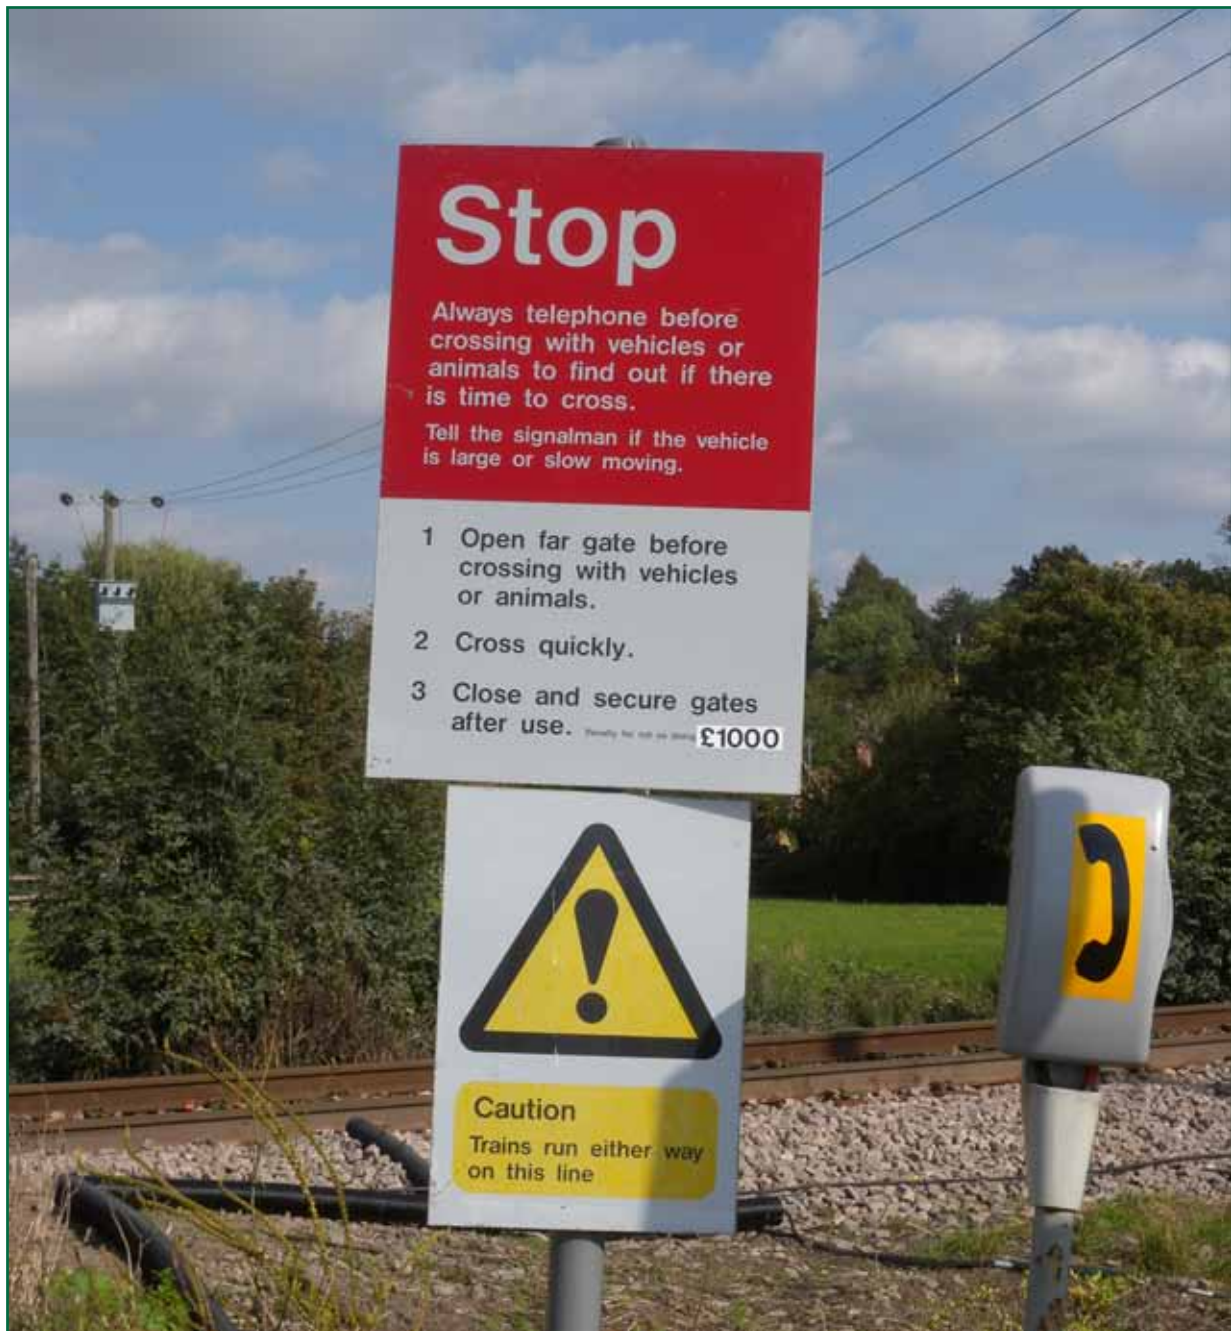
- 187 The signage at Sewage Works Lane UWC presented information in an unclear manner that did not promote safe use. This was a cause of some of the incidents of road vehicle users not calling the signaller to obtain permission to cross the railway.**

- 191 However, witness evidence indicates that the wording and layout of the signs at Sewage Works Lane UWC (figure 20) had caused other individuals to cross the railway without calling the signaller for permission (including one individual who used the crossing shortly before the accident). Of particular note is the mixture of numbered and un-numbered instructions. If a user read only the numbered items, they would miss the requirement to call the signaller before crossing with a road vehicle. Some users had their attention drawn to the text in bold and focused on the fine associated with failure to close the gates. Overall, the sign at this location was unclear and the requirement for all vehicles to call the signaller was lost within the large amount of other text.

Figure 20: Sign at Sewage Works Lane UWC
