Rail Accident Report

**Collision between an articulated tanker and a passenger train at Sewage Works Lane user worked crossing, near Sudbury, Suffolk
17 August 2010**

Collision between an articulated tanker and a passenger train at Sewage Works Lane user worked crossing, near Sudbury, Suffolk 17 August 2010

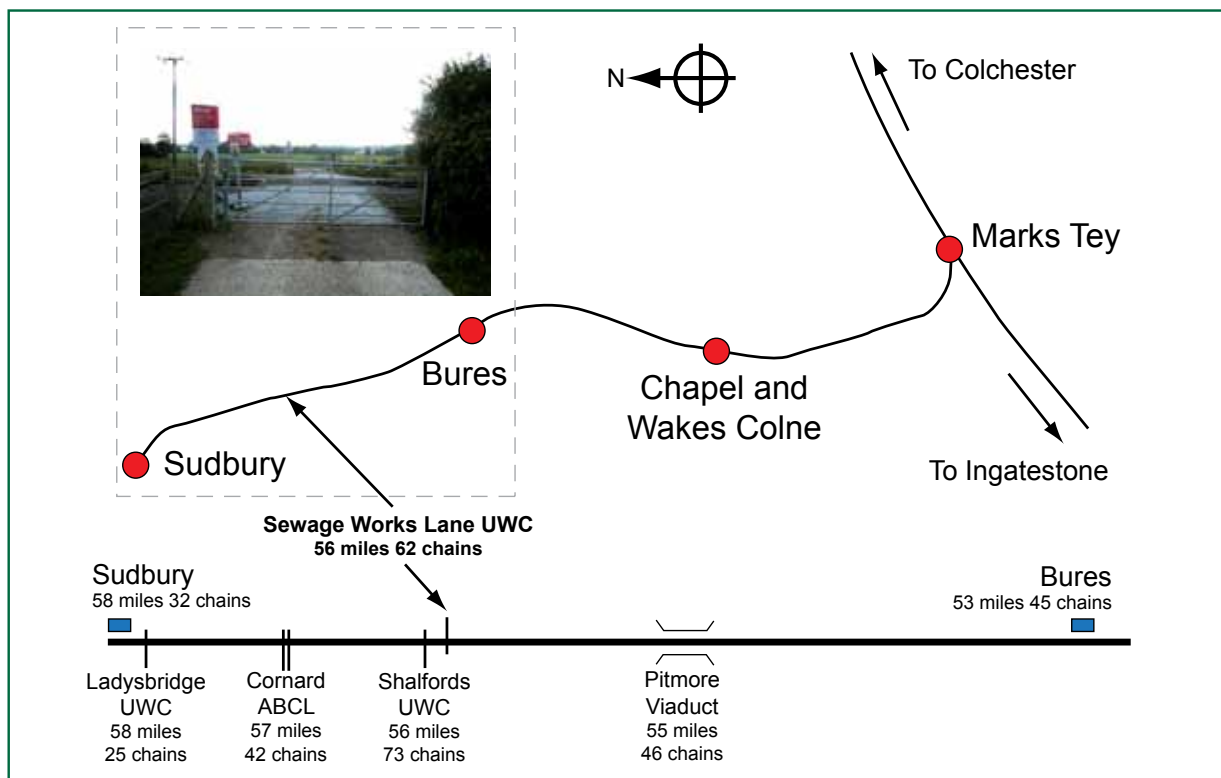
- 15 Sewage Works Lane UWC is located at 56 miles 62 chains on the branch line between Marks Tey in Essex and Sudbury in Suffolk, approximately two miles (3.2 kilometres) from Sudbury station (figure 3). It provides the principal vehicle access to the adjacent sewage treatment works. The crossing has a gate on each side of the railway. The gates are situated 12 metres from the nearest rail on the west (sewage works) side of the crossing and 8 metres from the nearest rail on the east side of the crossing. Telephones were² provided inside the gates on each side of the crossing. Signs positioned on the approach to both sides of the crossing instruct people using the crossing to open and close the gates, which are normally closed to the roadway. The signs also instruct the drivers of all road vehicles to call the signaller for permission to cross. At the time of the accident, the correct sequence of operation³ for a road user after arriving at the crossing was:

Figure 3: Map of railway infrastructure with image of crossing (inset)

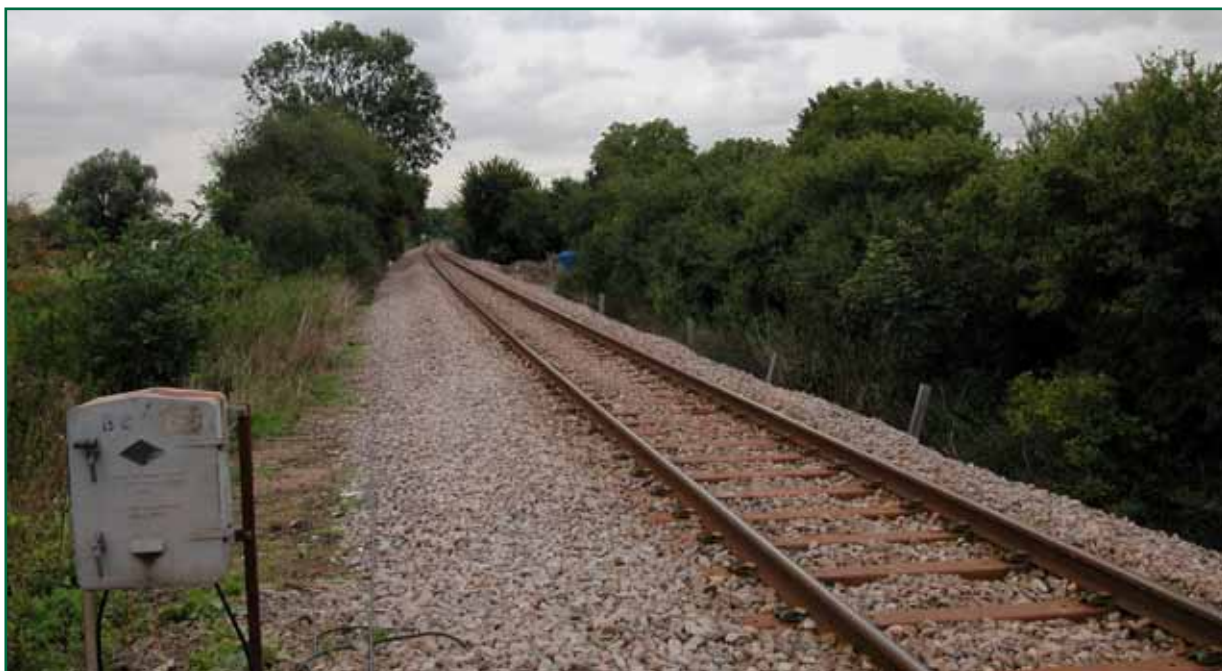
- 29 At approximately 17:00 hrs the tanker approached Sewage Works Lane UWC and then travelled over the crossing. The tanker driver did not call the signaller for permission to cross on his inward journey. The loading of the tanker within the sewage works was completed by around 17:25 hrs and the driver prepared his vehicle for departure and then returned towards the crossing, proceeding through the crossing gates and reaching the railway line (figure 5) at 17:33:30⁵ hrs.

Figure 5: View from Sewage Works Lane UWC looking towards Shalfords UWC and Sudbury.

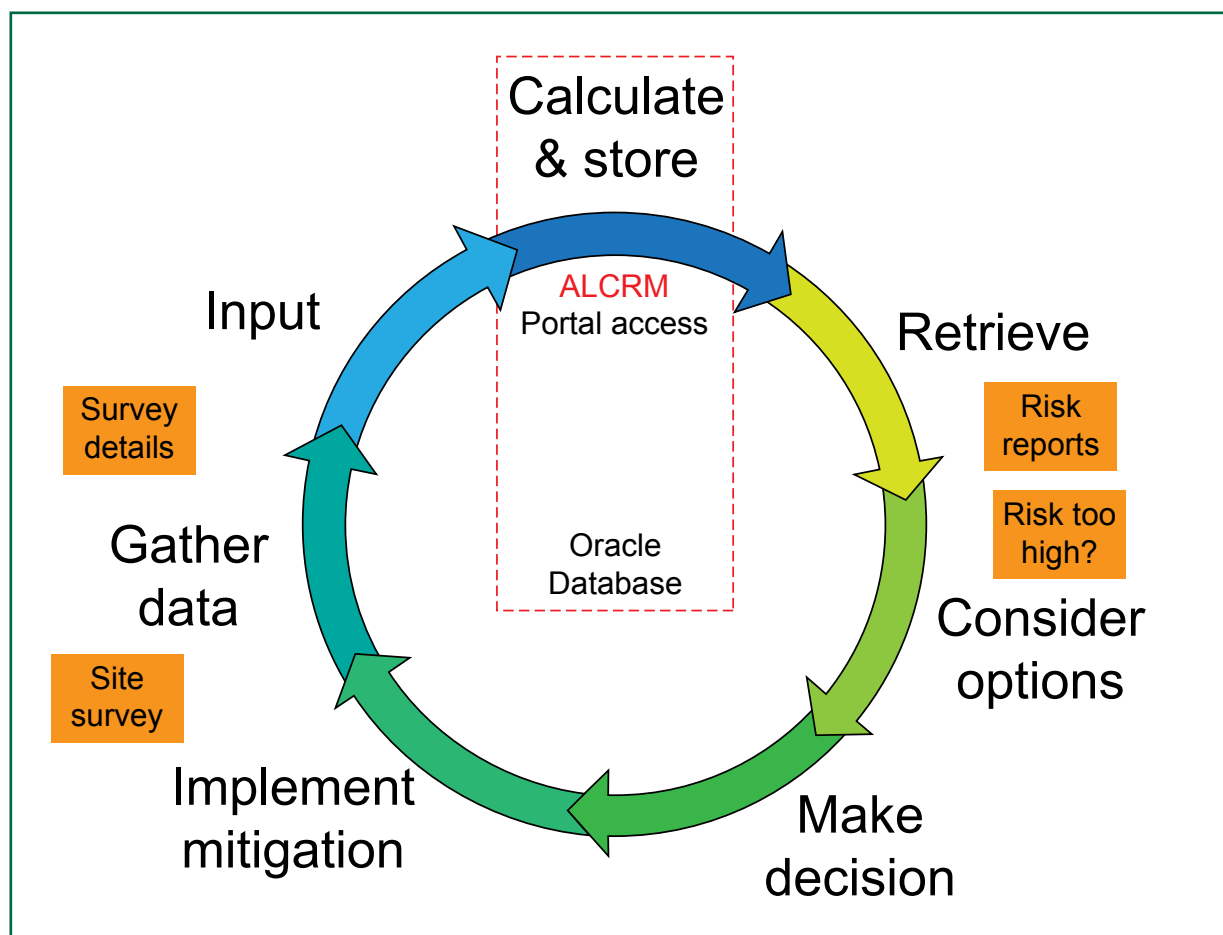
- 129 There were two principal components of the risk management process (figure 11):
- data gathering about the crossing; and
 - processing of the data gathered to provide an indication of the level of risk at the crossing and consideration of the outcome.

- 130 The gathering of data as an input to the risk assessment process for Sewage Works Lane UWC was characterised by errors and omissions in the information recorded and the predictable risk arising from the long waiting times for road vehicles at the crossing was not taken into account. This was an underlying factor in the accident on 17 August 2010.**

Figure 11: Diagram showing the business process in risk assessment of level crossings.

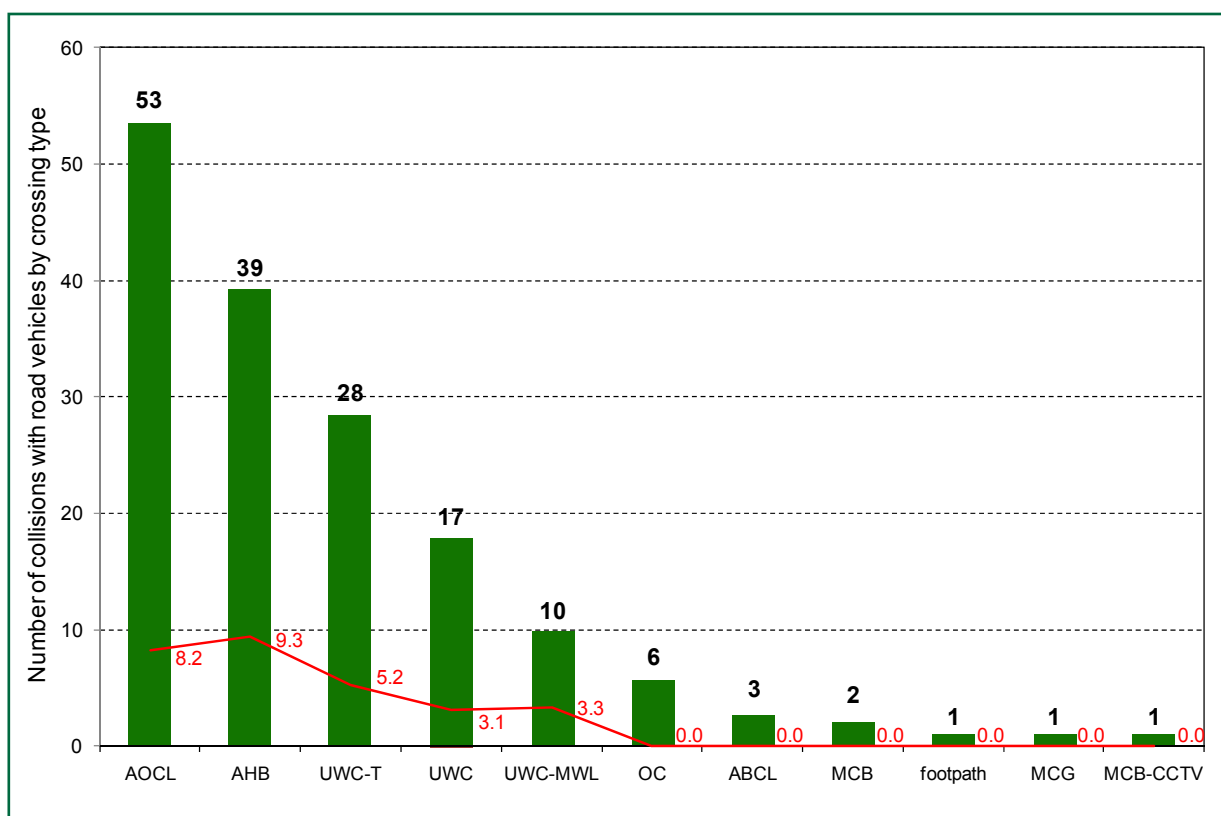
180 Figures 17 and 18 below are extracts from the special topic report and show the number of collisions that have occurred at different types of crossing in a ten year period and the risk arising from those collisions. The figures show that user worked crossings with telephones have the third highest number of collisions when compared with all other types of crossing and contribute the second highest level of overall risk, although they drop in rank to 7th when the figures are normalised by the number of such crossings on the network. Figure 18 also shows that the normalised risk at UWCs equipped with miniature stop (warning) lights is approximately six times higher than that at UWCs equipped with telephones. Miniature stop lights are normally provided on crossings with a higher level of underlying risk, often arising from much higher usage than applies at most UWCs. It should not be the case that risk will increase if miniature stop lights are provided at a crossing that has hitherto only been equipped with telephones. This has now been recognised by the railway industry (see paragraph 184 and its associated footnote).

Figure 17: Collisions at level crossings¹⁵ by crossing type over ten years (reproduced by courtesy of RSSB)

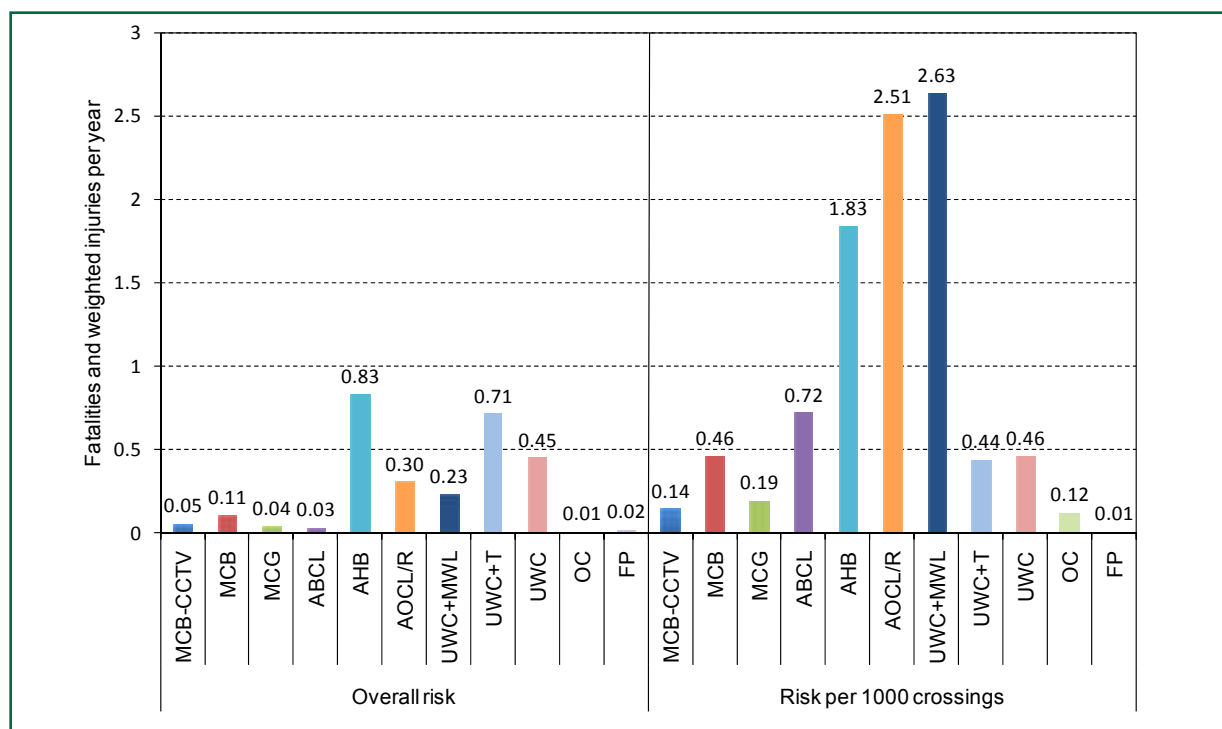
Figure 18: Risk from trains striking road vehicles, based on data contained in RSSB's Safety Risk Model, Version 6 (reproduced courtesy of RSSB)

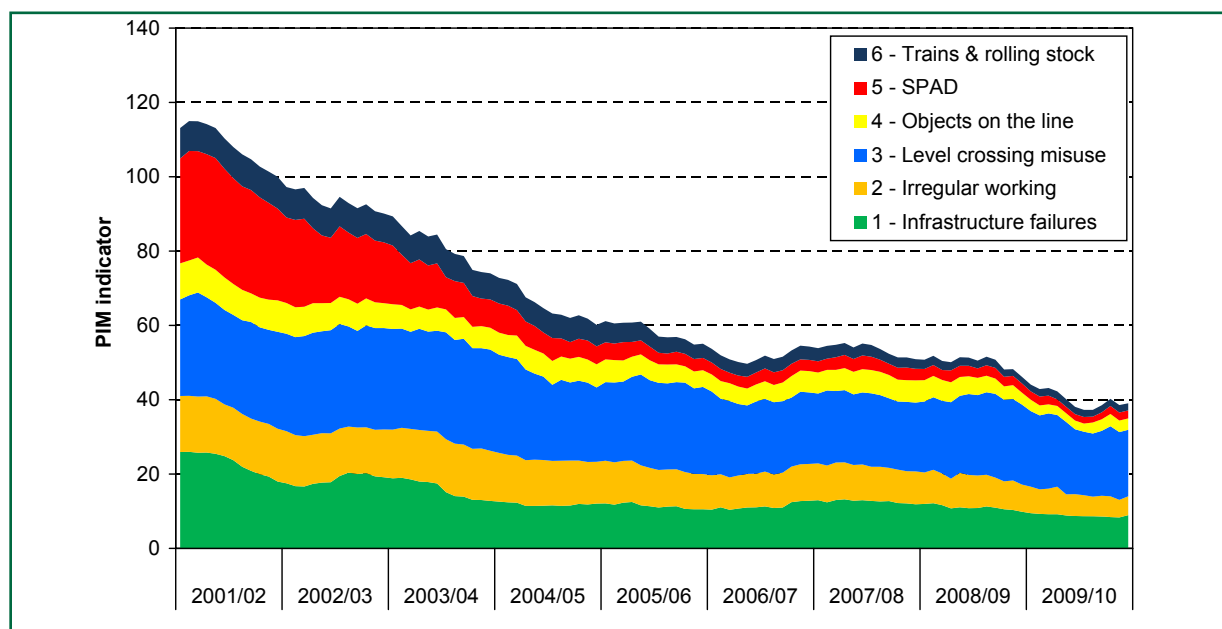
181 While the railway industry has made significant progress in reducing risk in a number of categories in the last ten years, risk from level crossing misuse (by members of the public) has seen a smaller reduction in risk in the same period. This is illustrated in figure 19 below, reproduced from the RSSB's Annual Safety Performance Report 2009/2010¹⁶.

Figure 19: Trends in train accident risk 2001-2010¹⁷ (reproduced by courtesy of RSSB)
